## **REEF LIGHT INSPECTION CARYSFORT REEF LIGHT**

**UNITED STATES COAST GUARD  
OFFSHORE KEY LARGO, FLORIDA**

**USCG Task Order No.: HSCG82-10-J-PMV228  
Contract No.: HSCGG1-10-D-PRV090**

September 2010

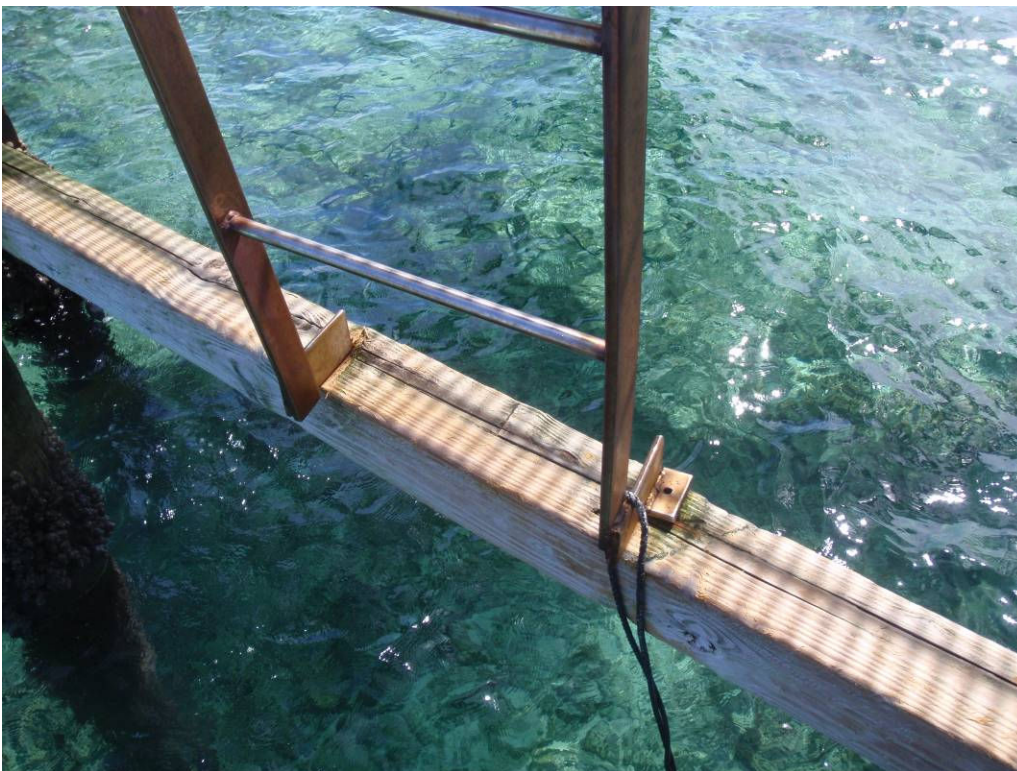
**Photo 6-29**

The timber whaler at the top of the north side of the boat landing has an area of heavy deterioration 6' long by up to 4" deep. The timber mooring piles are in good condition; however, the rubber rub rails are too small. Ladders on the boat landing are located on the north and east sides. Welds attaching the rails of the north ladder to the platform are cracked while the bottom of this ladder is secured to the platform with rope. Bolts for connecting the bottom of the east ladder to the boat landing are missing; the ladder is not secured to the platform, it is only resting on a timber beam (Photo 6-29).

Missing bolts at base of east boat landing ladder.

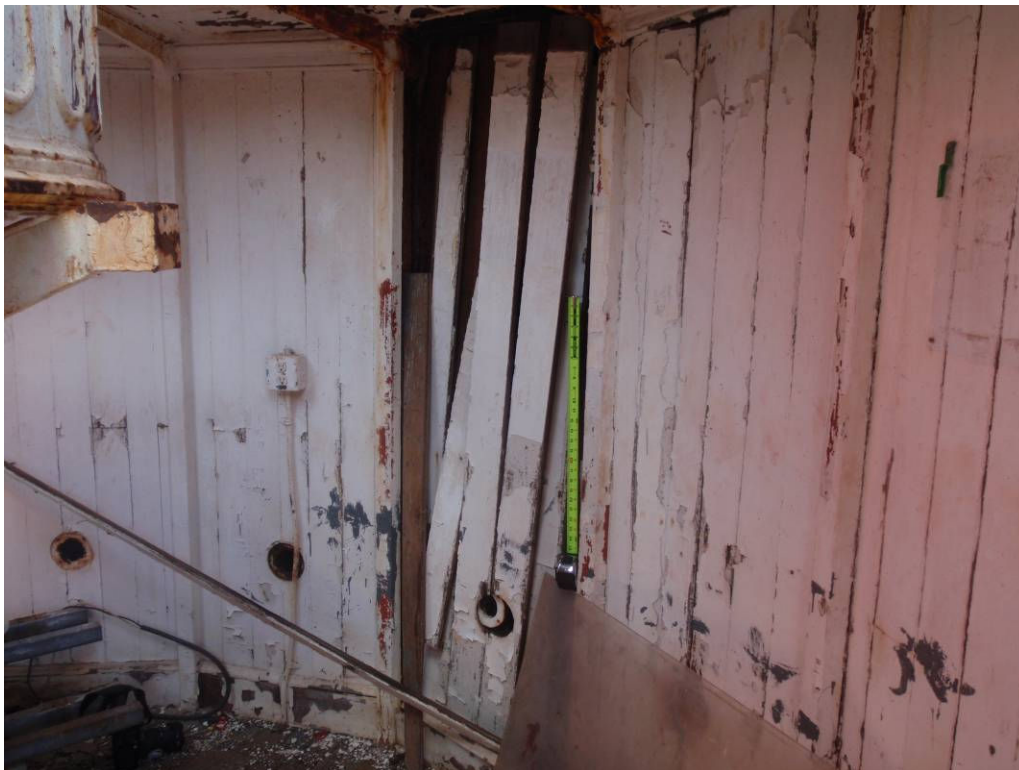
**Photo 6-30**

Damaged wall paneling in watch room.

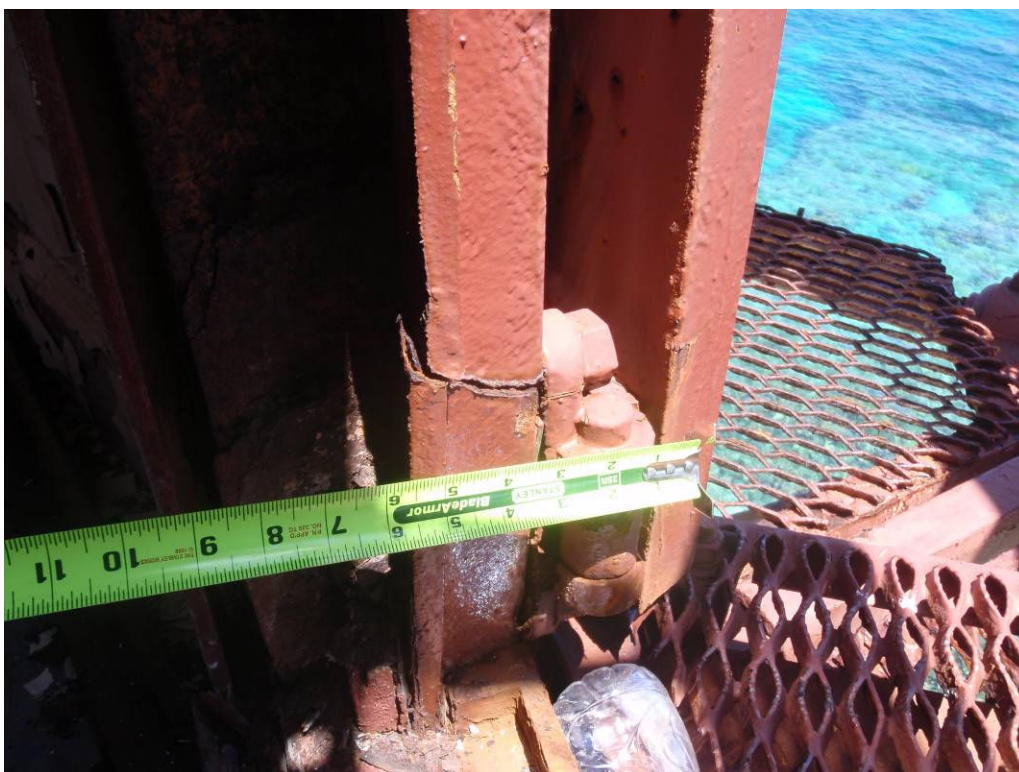
**Photo 6-31**

Cracks in watch room exterior door frame.

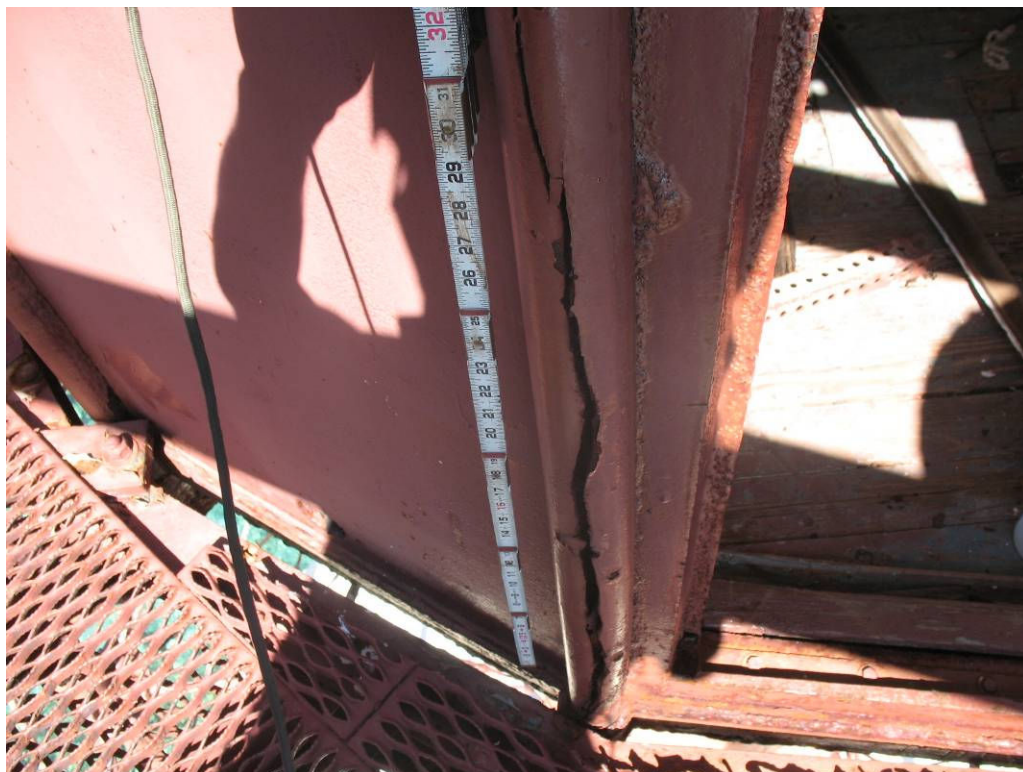
**Photo 6-32**

The tower and Lantern Room are in **fair** condition. Approximately 20% of the timber floor in the lantern room is deteriorated. The wood paneling around the walls of the lower portion of the lantern room has approximately 40% coating loss. A 2' wide section of wall paneling is damaged (Photo 6-30). The exterior door frame has cracks at top and bottom up to 1/16" wide (Photo 6-31). Semi-circular iron members covering the joints between wall sections on the exterior of the lower portion of the watch room have cracks up to 1/4" wide with heavy corrosion (Photo 6-32).

Cracks and heavy corrosion on iron members covering the joints between exterior watch room wall sections.

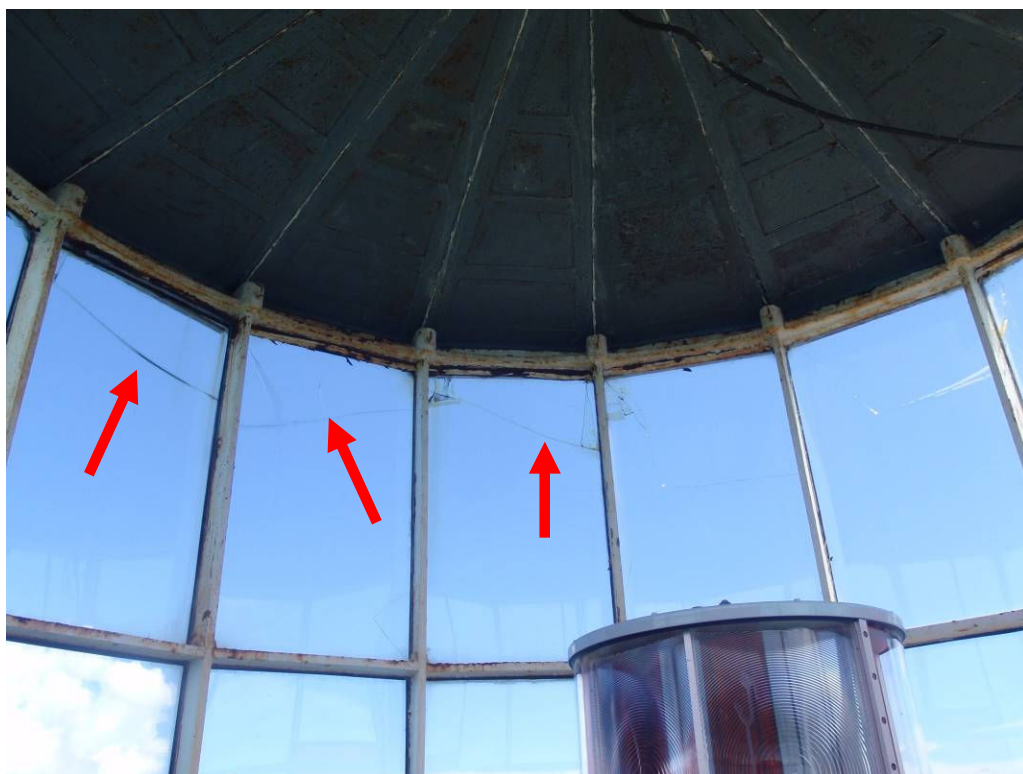
**Photo 6-33**

The window frames in the upper portion of the lantern room have approximately 20% coating loss with light corrosion. Nine window panes are cracked in the top row, 1 in the middle row, and three in the bottom row (Photo 6-33). Three sections of the top window sill have moderate corrosion. Vents around the interior catwalk have isolated areas of moderate to heavy deterioration. The interior of the lantern room roof has approximately 10% coating loss with light corrosion.

Cracked window panes in lantern room.

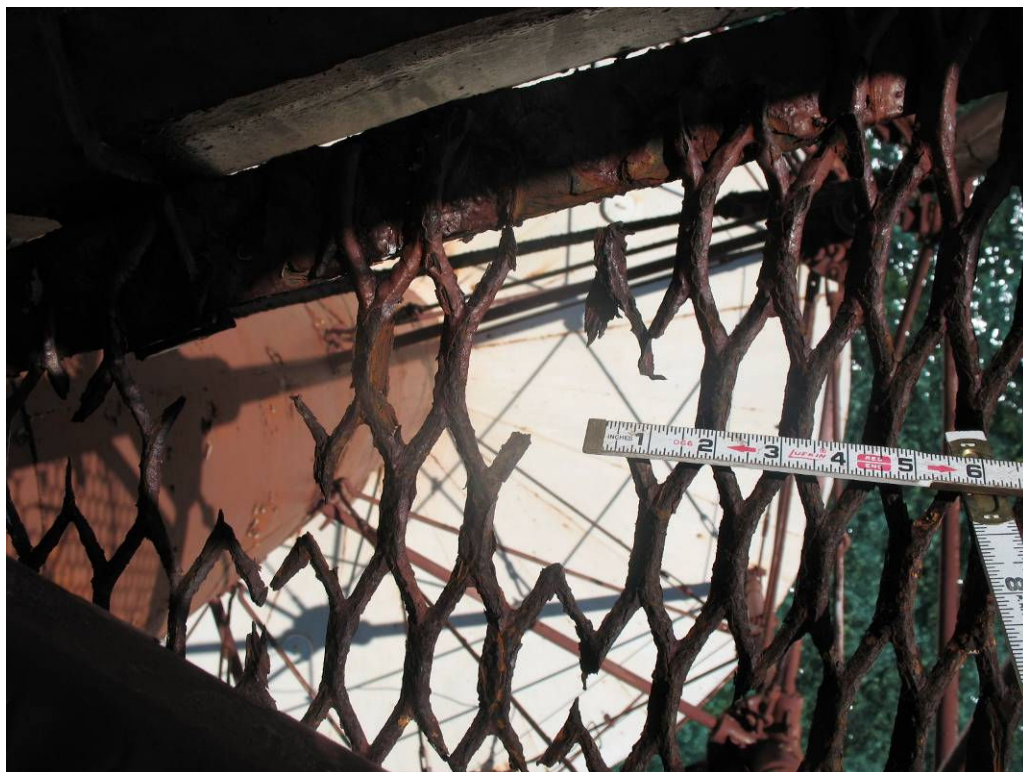
**Photo 6-34**

The exterior catwalk grating has moderate to heavy corrosion with areas of 100% section loss (Photo 6-34). Multiple U-bolts securing the catwalk grating are broken. Several secondary catwalk support members have 100% section loss (Photo 6-35). Four handrail sections are missing or broken (Photo 6-36). The frame supporting the solar panels has light corrosion. One solar panel is missing.

Moderate to heavy corrosion on exterior watch room catwalk grating.

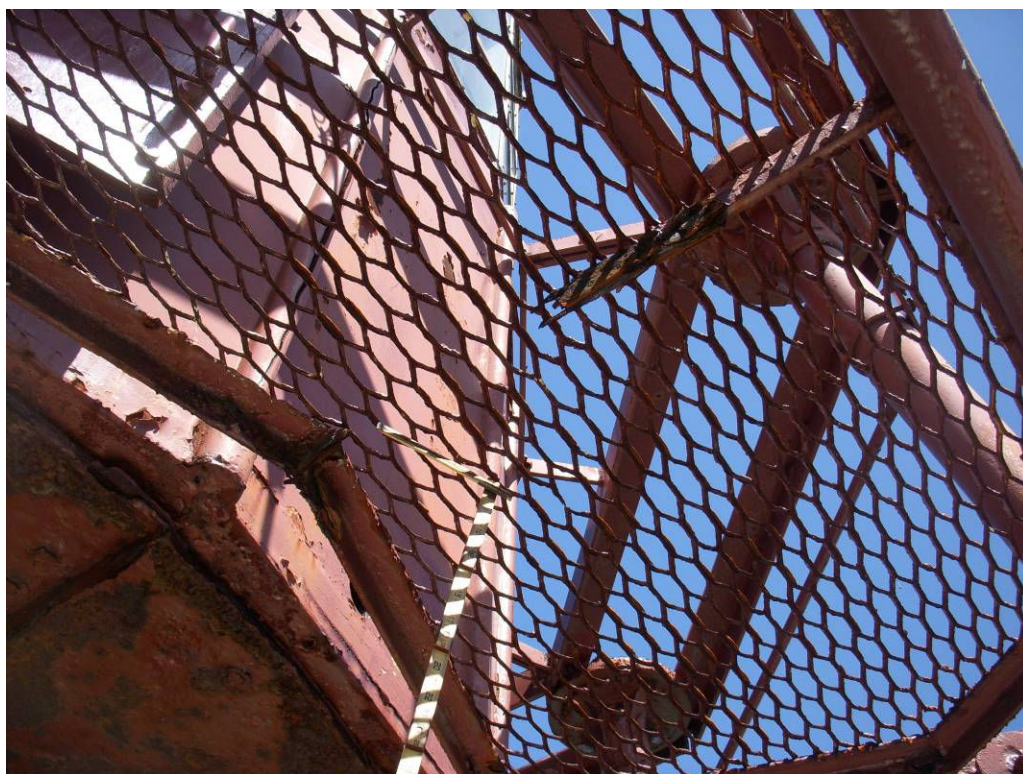
**Photo 6-35**

Section loss on secondary watch room catwalk support members.

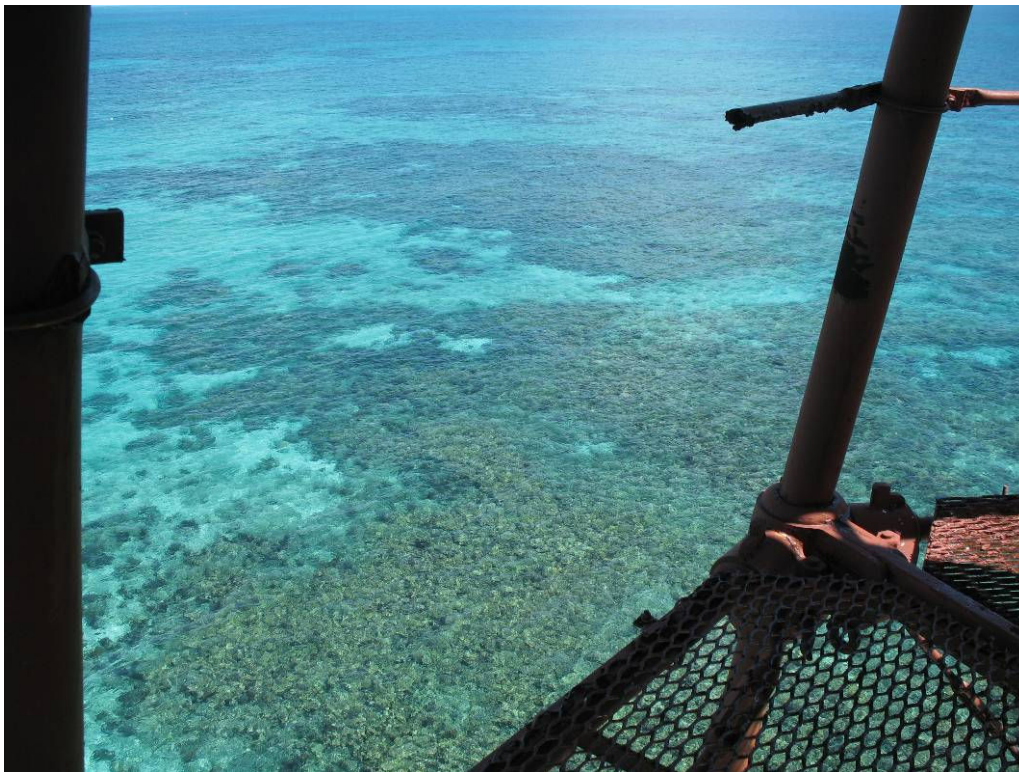
**Photo 6-36**

Typical broken handrail sections on watch room catwalk.

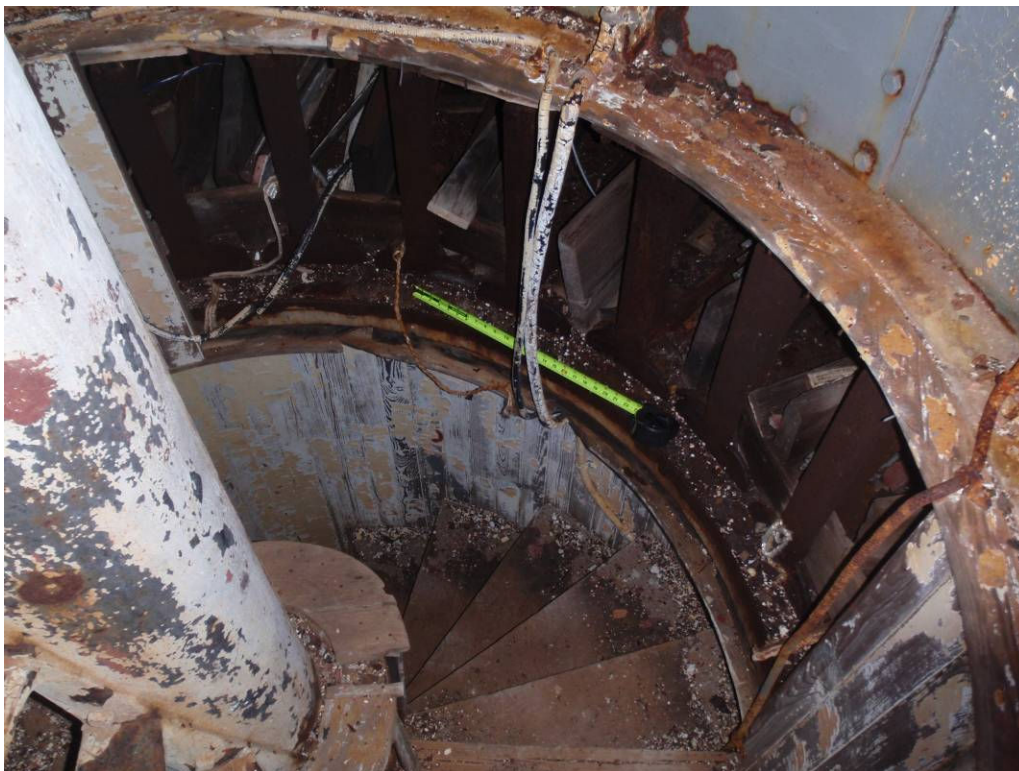
**Photo 6-37**

The stairs are in **fair** condition. Wood paneling in the stairwell within the dwelling has 70% coating loss. At the level of the roof, a 4' long by 18" high area of paneling is missing (Photo 6-37). Hinges on the door leading from the stairs to the dwelling roof are broken (Photo 6-38). The stairs are a combination of metal and timber treads; all are in good condition (Photo 6-39). Above the dwelling, the stairs are enclosed in an iron cylinder. The inside of the stairwell has 40% coating loss. Two portholes are broken and one is missing near the top. The ladder from the stairwell into the lantern room is not connected at the top or the bottom (Photo 6-40).

Missing wall paneling inside of stairwell.

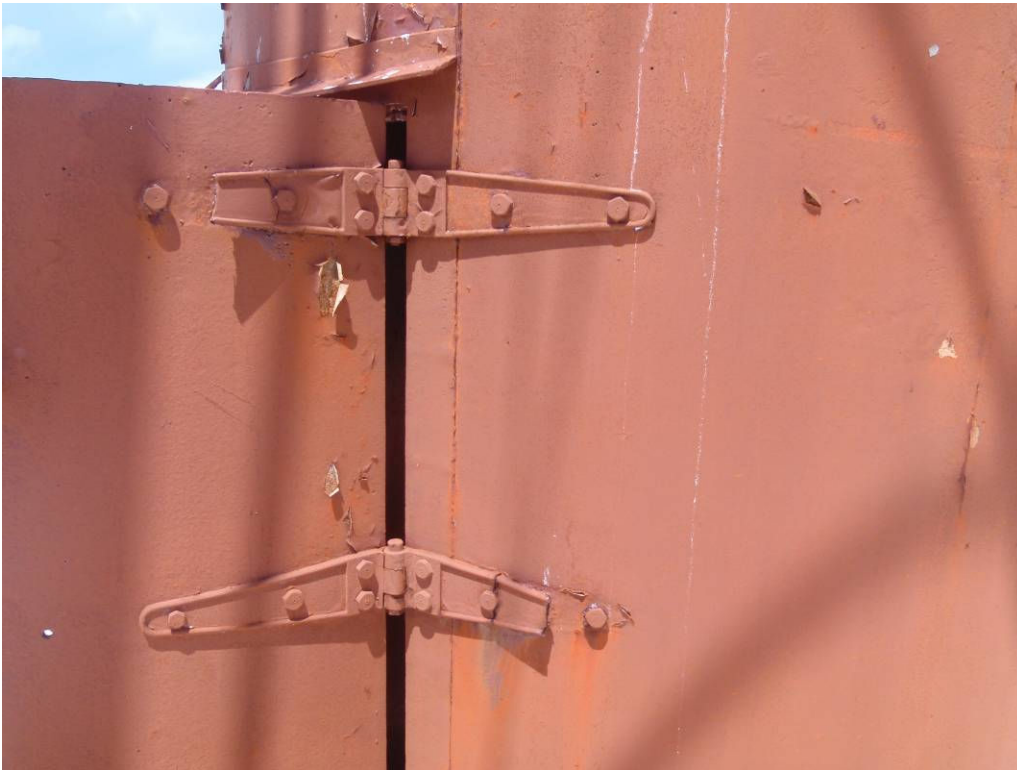
**Photo 6-38**

Broken hinges on the door leading from the stairs to dwelling roof.

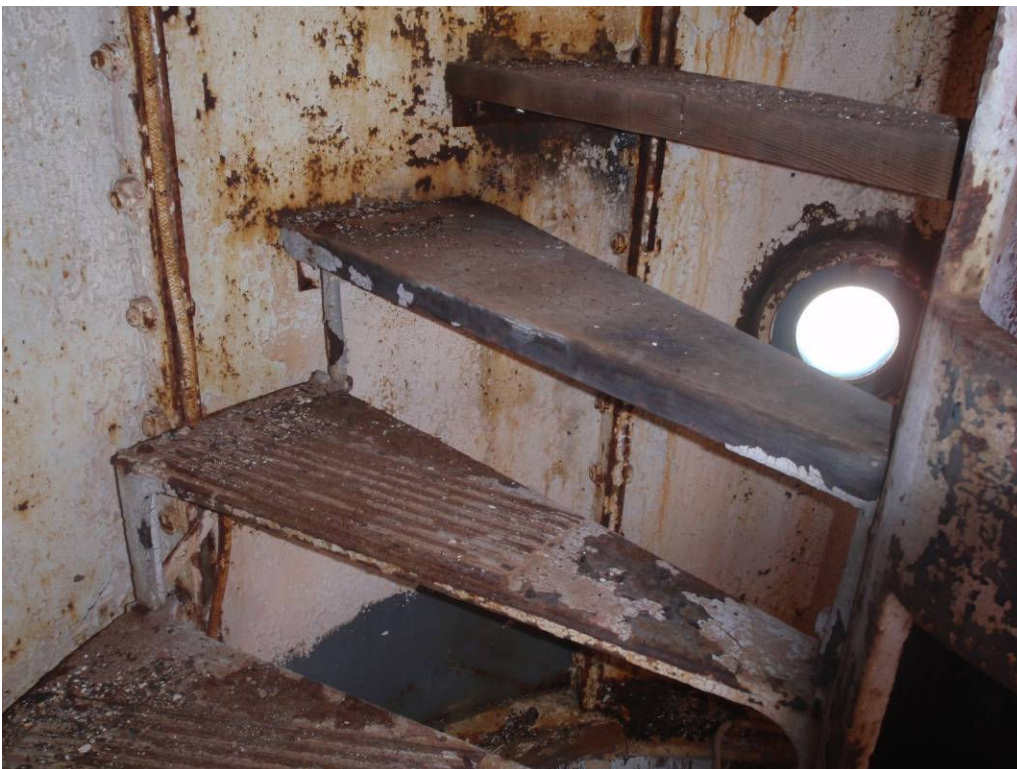
**Photo 6-39**

Stairwell treads are in good condition.

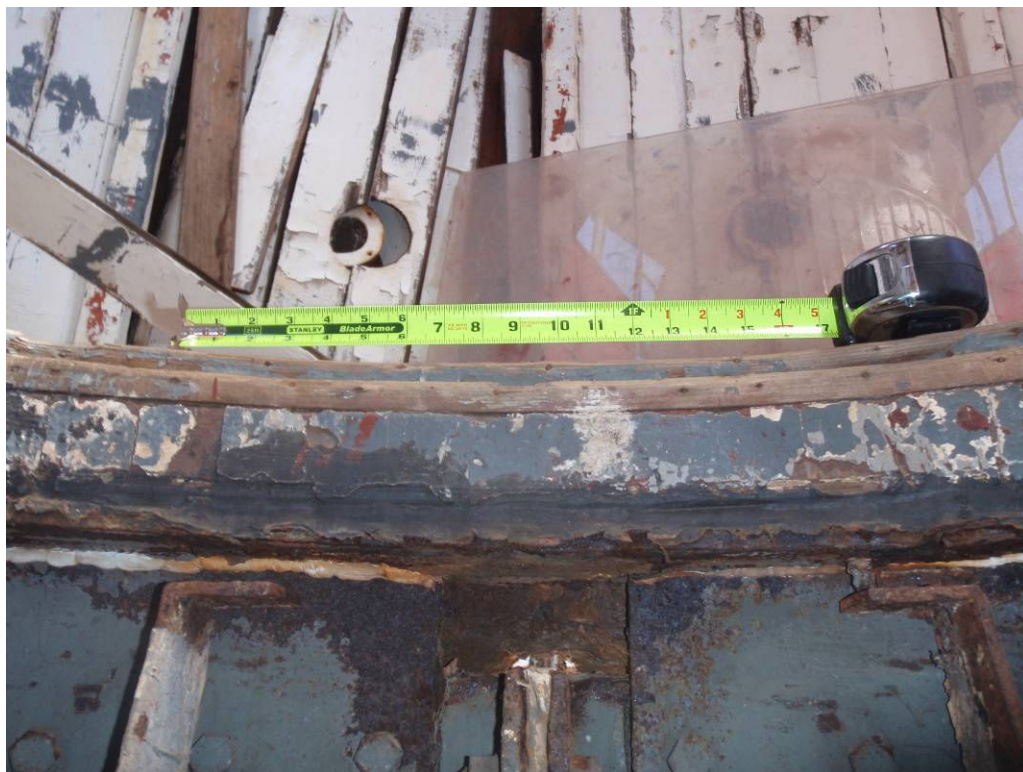
**Photo 6-40**

Ladder from the stairwell to the lantern room is not connected at the top or the bottom.

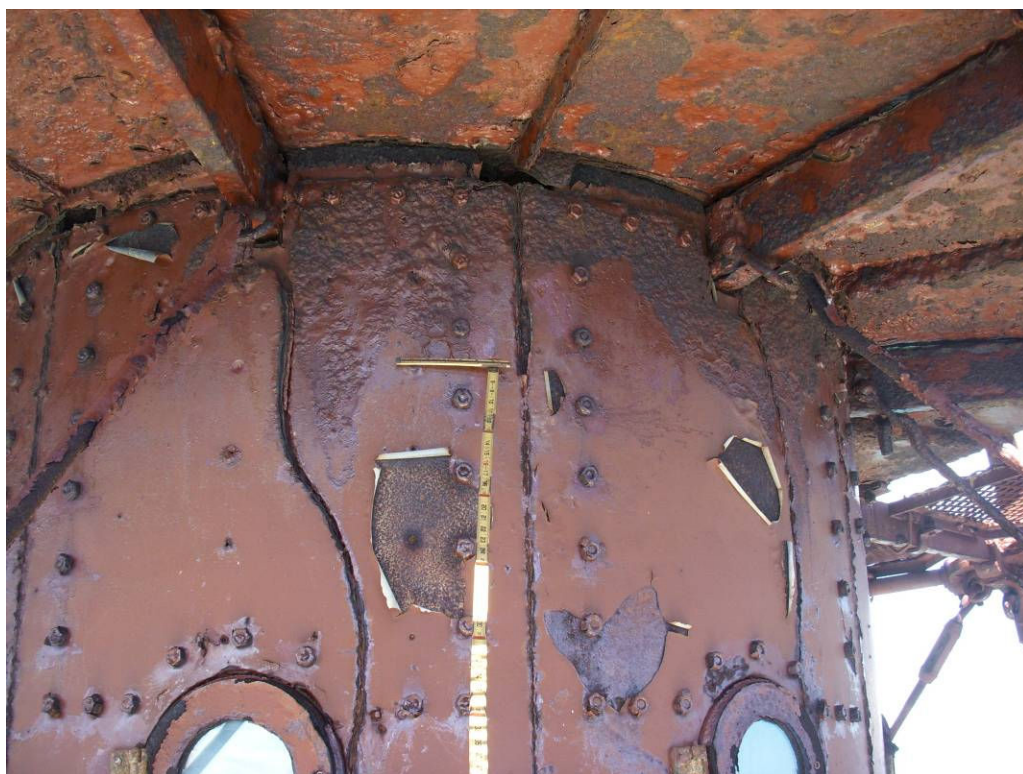
**Photo 6-41**

Each of the eight stairwell cylinder wall panels just below the lantern room has one vertical crack up to 1/8" wide. These cracks typically extend between 1' and 2' down from the top of the panel (Photo 6-41). The wall panel near Column 8 has two cracks. The crack in the wall panel near Column 5 extends from the top of the panel to 10" from the bottom of the panel (Photo 6-42). Supplemental steel plates are bolted to the top half of each stairwell wall panel on the interior of the stairwell (Photo 6-43).

Vertical cracks in the stairwell wall panels below the watch room.

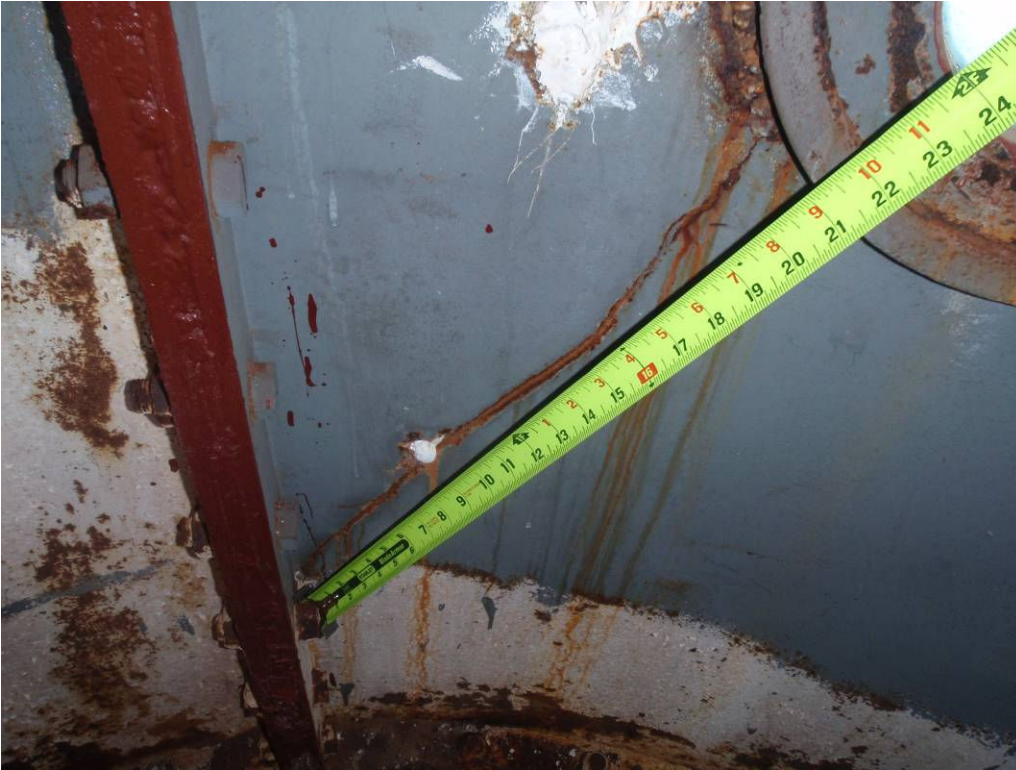
**Photo 6-42**

Crack in the stairwell wall panel at the top near Column 5 extends from the top of the panel to 10" from the bottom of the panel.

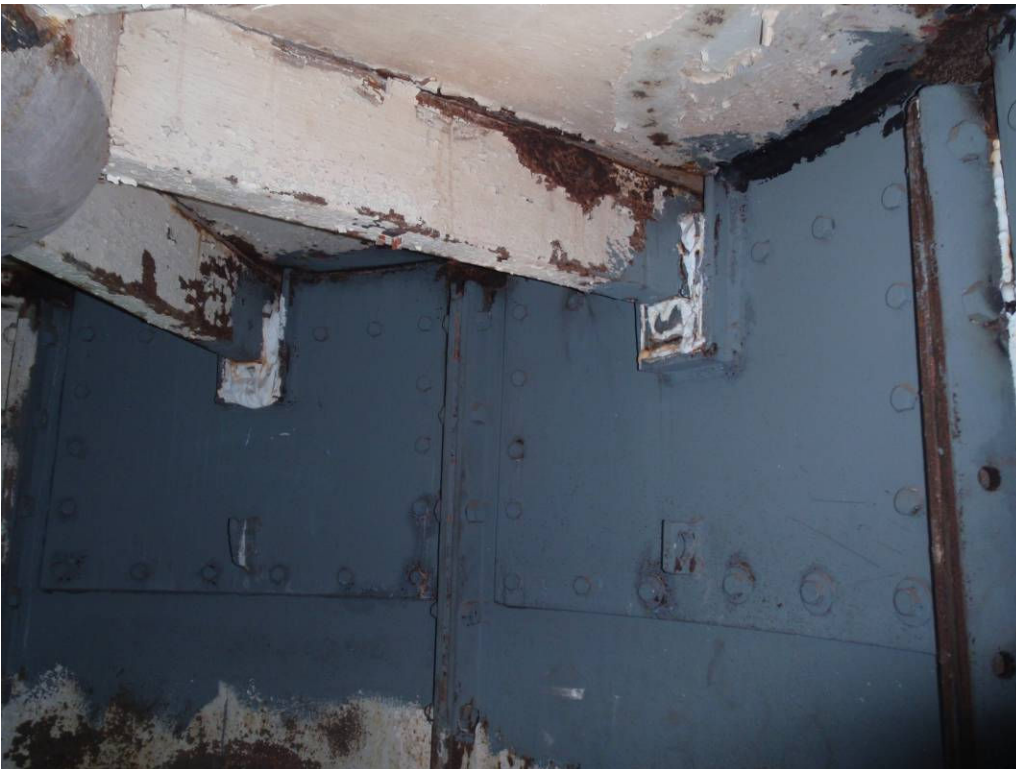
**Photo 6-43**

Supplemental steel plates bolted to the top half of each interior stairwell wall panel at the top of the stairwell.

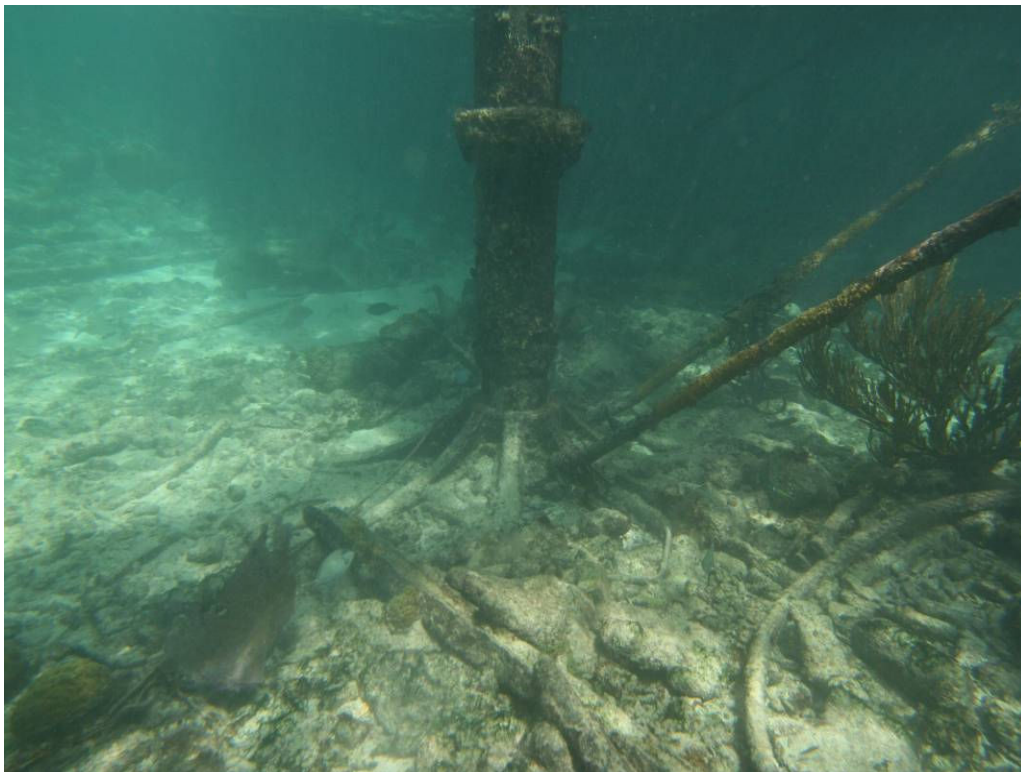
**Photo 6-44**

Underwater components are in satisfactory condition.

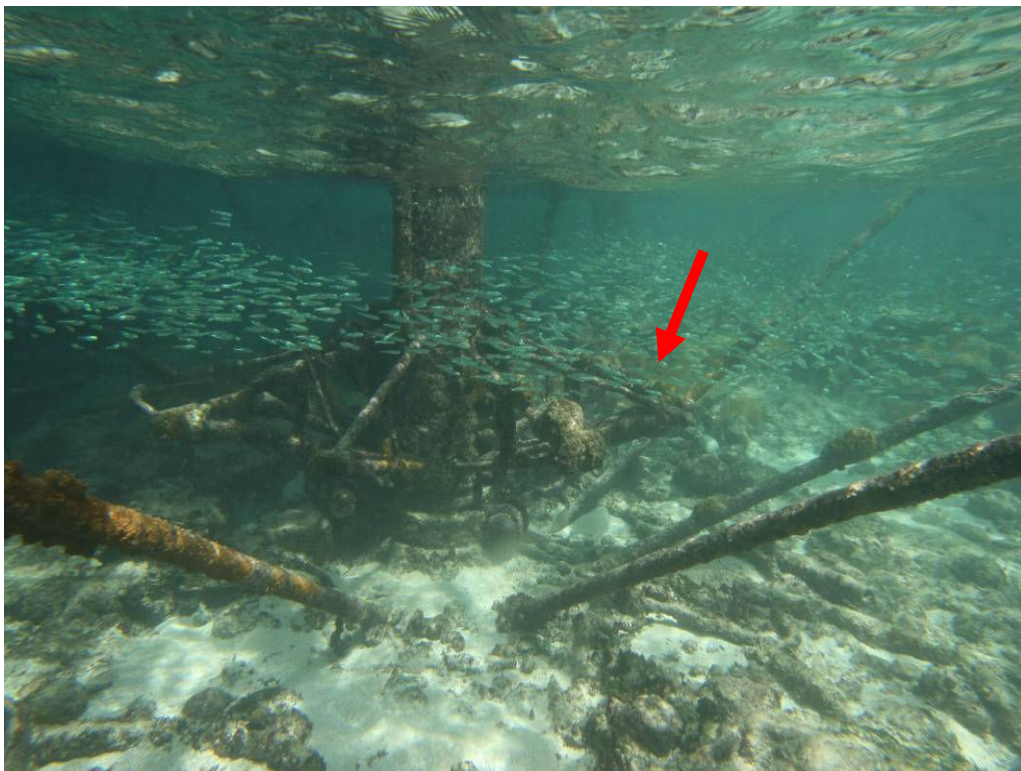
**Photo 6-45**

The underwater components of the reef light are in **satisfactory** condition. No defects were noted at the time of inspection (Photo 6-44). Brackets for cathodic protection anodes are broken off of Column 9; no anodes are present (Photo 6-45).

Broken brackets for cathodic protection anodes, no anodes present.
